Low-Velocity Impact, Free-Fall Drop Test of Prototype, and Failure Analysis of Hybrid Palm / Kenaf Reinforced MWCNT Phenolic Composites

The research's aim is to investigate the energy absorption, free-fall drop analysis, and failure analysis of Palm (P)/kenaf (K) fiber-reinforced MWCNT-phenolic composites. 3P:7K reinforced MWCNT-phenolic composites were made using manual mixing and hot pressing at 150°C with a pressure of 10 tonnes. Energy absorption was investigated using a drop weight impact tester. Free-fall drop test was performed to analyze the performance of the aircraft tray table prototype. Non-destructive testing was carried out to investigate the damage mechanism. The results demonstrate that as the impact energy increased from 1.50 J to 3.0 J, the crack length increased. There is a difference of 3% to 15% in the crack sizing between dye penetration and Digital Detector Array (DDA), indicating that DDA is more accurate. In the free-fall drop test, small cracks were detected in the dye penetration method on the prototype. The DDA approach, however, did not reveal any defects. The agglomerations were observed through DDA and Computed tomography. In this study, the hybrid C

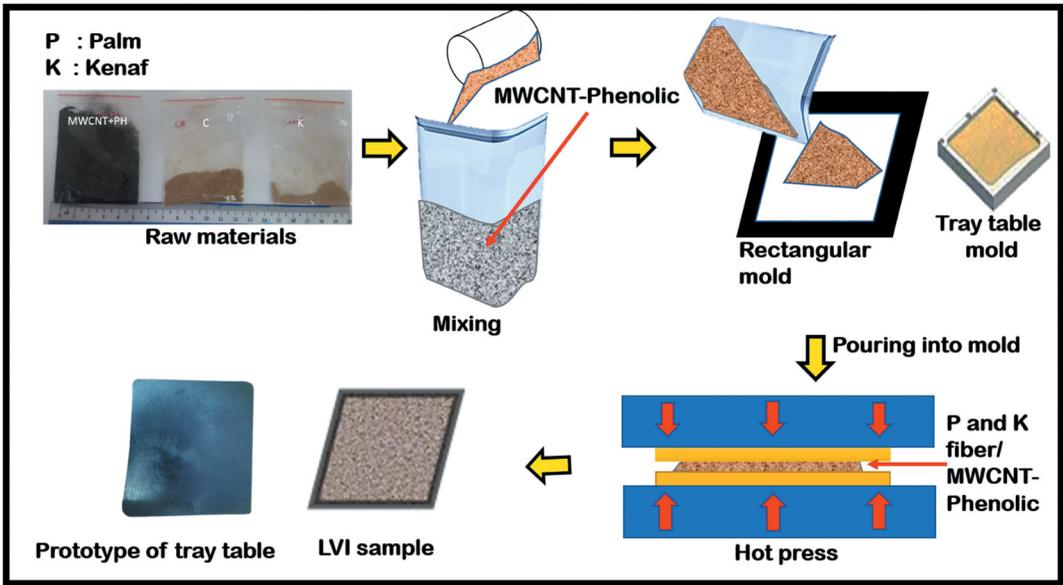
Figure 1. Schematic diagram of hybrid composite preparation for LVI and prototype of tray table.

were produced using a manual mixing technique with a mold size of 150 mm × 100 mm × 3 mm. The fiber was uniformly mixed manually with 0.5 wt% MWCNT–phenolic resin for 15 min. The mixture was then adequately spread into the mold. The mold was placed in a hot press with a temperature of 150°C and pressure of 10 tonnes, as illustrated in Figure 1. The composites were compressed for 10 min and were cold-pressed for 5 min.

Drop-weight impact testing was performed to investigate low-velocity impact behavior of the hybrid bio-composites. The testing was performed with three repeatability samples on an instrumented drop weight impact tester model, IMATEK IM10, in accordance with ASTM D7136 as shown in Figure 1. The instrument was equipped with a data acquisition system, which records power, time, displacement, velocity, and energy absorbed by the samples being measured. Specimens with dimensions of 150 mm × 100 mm × 3 mm were clamped using rubber tip toggle clamps at four points with an equal clamp force in the impact support fixture with a cutout rectangular opening. A hemispherical tip striker with a radius of 5 mm and a weight of 5.101 kg was dropped onto the clamped composite sample from a calculated height. The impact energy added to the samples varied from 1.5 J to 3.0 J, and various heights were used to reflect different magnitudes. The impact energy, E , was measured using Equation (1) below:

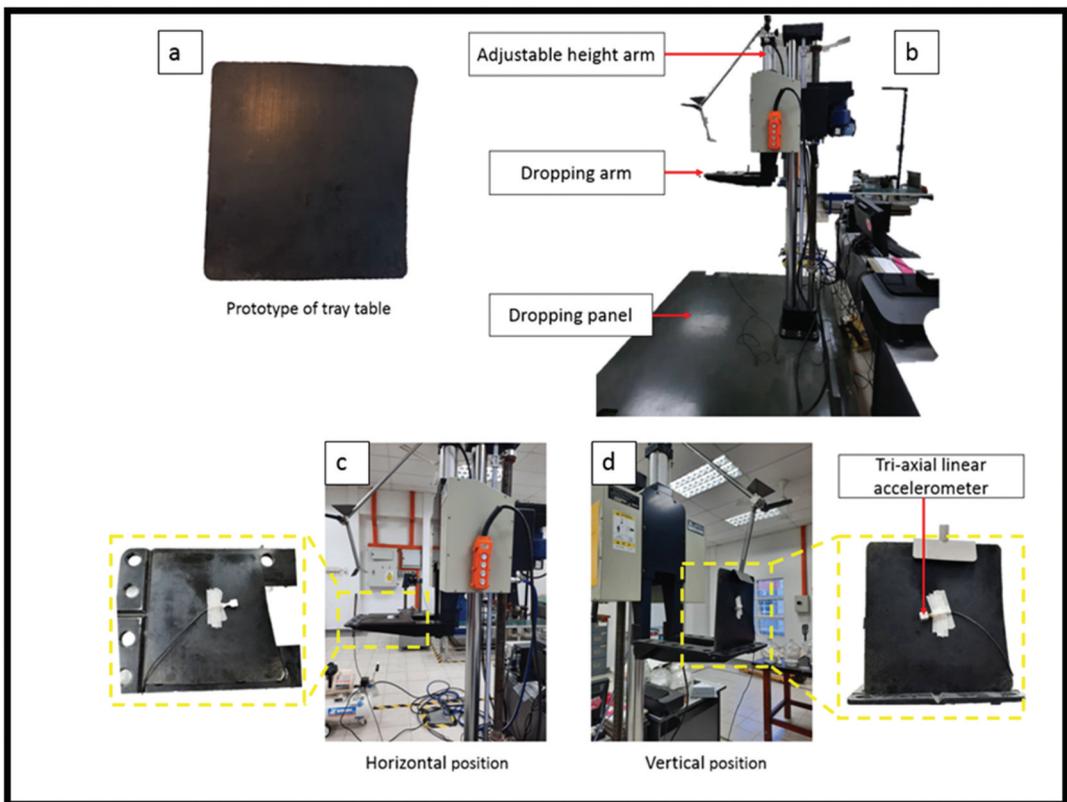
Figure 2. (a) Prototype of tray table, (b) Free-fall drop tester, (c) Prototype dropped in horizontal position and d) vertical position.

A drop tester machine for free-fall drop tests an object that can be dropped freely from a certain altitude to determine the capability of the object to withstand the sudden shock of a free fall. The prototype of an aircraft tray table was tested for free-fall drop at a maximum height of 130 cm in horizontal and vertical positions with three repetitions, respectively, using an air-arm-type drop, model KD-128A, manufactured by King Design Industrial Co-Ltd, Taiwan. The free-fall drop test was performed in compliance with ASTM D5276, as shown in Figure 2. The drop tester instrument was equipped with a data acquisition system for data analysis. The benefit of this testing is that the object falls spontaneously, resulting in a more realistic drop testing.

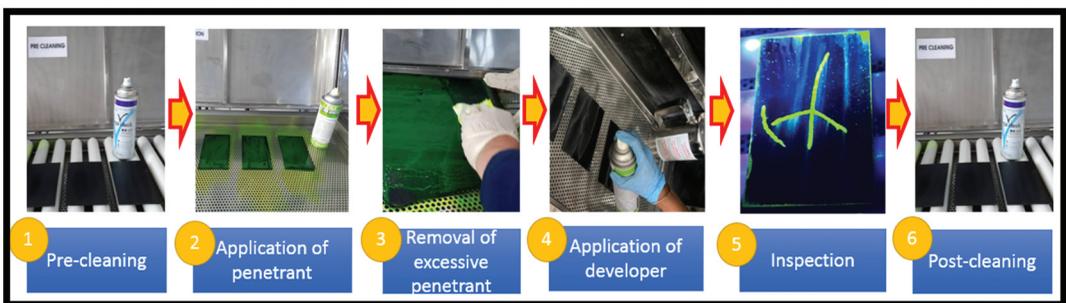
Figure 3. Procedure of dye penetration testing.

capillary action. Liquid penetration inspection was performed on the low-velocity impact samples and prototype of tray table as a posttest in order to indicate and identify cracks, impact fractures, and matrix failure. This testing was carried out in accordance with ASTM E1417. This process involved six stages, which were (1) pre-cleaning, (2) application of penetrant, (3) removal of excessive penetrant, (4) application of developer, (5) inspection of test surface, and (6) post-inspection cleaning, as shown in Figure 3. In the pre-cleaning stage, the composite surface was sprayed with solvents and allowed to dry to prevent any soil, paint, oil, or grease. The fluorescent penetration was then applied on the composite surface. It took approximately 20 min for the penetrant to “dwell” in any defects on the surface. The residual penetrant was then wiped away from the surface with a lint-free cloth. Residual penetrant was removed in one direction, either vertically or horizontally. A developer was applied to the sample after the excess penetrant was removed. For fluorescent penetrant examinations, sufficient ultraviolet (UV-A) radiation ($1,000 \text{ uW/cm}^2$) as well as low ambient light levels (less than 20 lux) were required. The post-inspection process was done with solvents on the inspected composites.

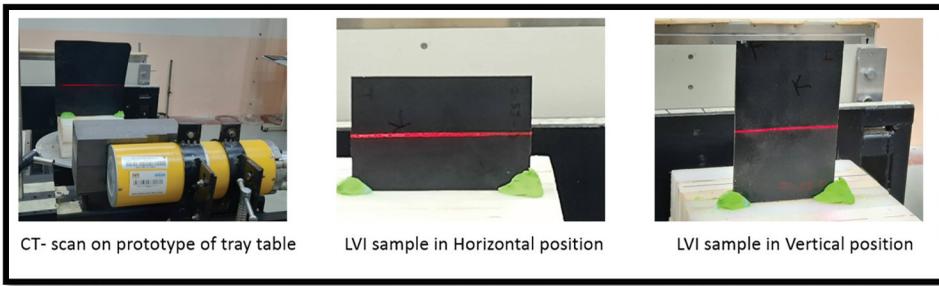
Figure 4. CT scanning.

X-rays are used in computed tomography (CT) to produce 3D cross-sectional images as a volumetric representation. The impact damage of the LVI test and the free-fall drop test were studied in this work using an X-ray Computed Tomography System model XYLON, MGC 41 as shown in Figure 4. The focal spot size, source detector distance (SDD), and source object distance (SOD) for the LVI samples were set to 1 mm, 1000 mm, and 400 mm, respectively, with a maximum voltage of 30 kV and current of 2.0 mA. Meanwhile, for the prototype of tray table, the focal spot size, SDD, and SOD were set to 1 mm, 1000 mm, and 500 mm, respectively, with maximum voltage of 50 kV and current of 3.0 mA. The tests were conducted in accordance with ASTM E1441. The Linear Array Detector (LAD) detector system was used with a resolution of 0.4 mm/pixel. The sonogram images acquired from the CT-scan were created using Octopus tools.

In the CT-scan method, the cross sections of the horizontal and vertical positions of the LVI samples' defect were investigated. As seen in Figure 4, the CT-scan was used to analyze the cross section of the composite plate around the damaged area's middle (indentation). The crack was observed at several locations along the cross-sectional view for the all the samples with various impact energy levels. The images illustrate that none of the samples had undergone perforation. The first form of failure is matrix cracking, which occurred as a result of the low-velocity impact effect caused by tension, compression, and shearing. Matrix cracking can be classified into two types: shear cracking (inclination of 45°) and bending crack (vertical inclination) (Safri et al. 2014). The bending crack propagated until the matrix cracked. The white dots in the images are agglomerated MWCNT, similar to the DDA. The agglomerated MWCNT acts as a stress concentrator, which leads to crack branching. A similar finding was reported by Shokrieh et al. who found that a large agglomeration of nanotubes as a stress concentrator causes the sample to fail at lower stresses (Shokrieh, Saeedi, and Chitsazzadeh 2013). The CT-scan for the tray table demonstrated that a small crack was found exactly at the agglomeration of MWCNT. As mentioned previously, an agglomeration of MWCNT in the phenolic acts as a stress concentrator and weakens the region as illustrated in Figure 11.

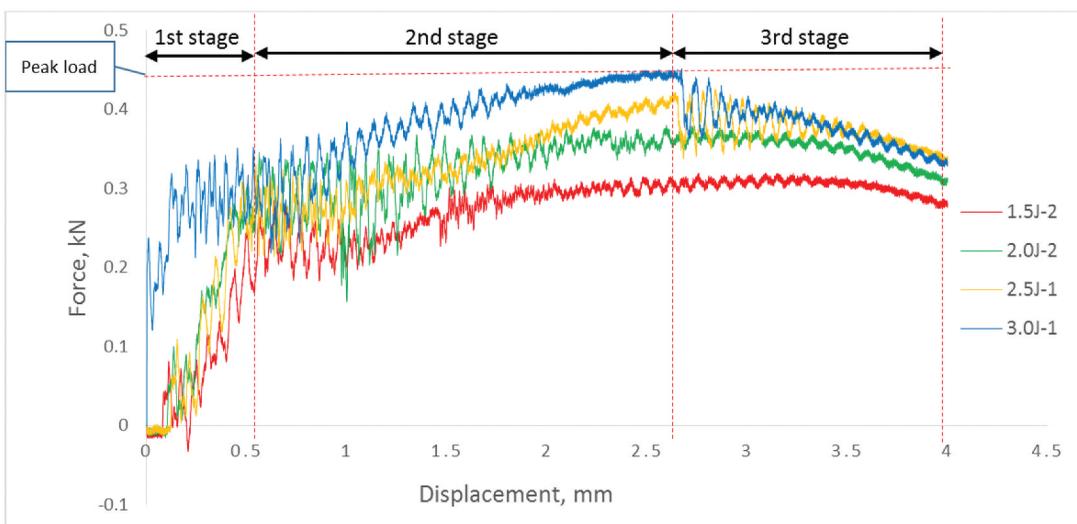
Figure 5. Force vs displacement curve of 3P:7K hybrid bio-composite.

Figure 5 displays the force–displacement curve of 3P:7K hybrid composites, with the impact energy level varying from 1.5 J to 3.0 J. In general, three stages of deformation are associated with the drop test distortion, which are (1) stopping and rebounding, (2) stopping but not rebounding, and (3) perforation (Ismail et al. 2019a, 2019b). The open curve in the graph below indicates that a perforation had occurred. The impactor's kinetic energy was transferred to the specimen and stored partially in the elastic deformation, with the remaining energy being dissipated as inertia, heat, and sound (Ismail et al. 2019a). The final energy value represents the cumulative energy dissipated by the specimen due to the occurrence of damage within the composites.

Table 2 presents the raw data obtained from the drop test data acquisition system. Referring to the data from Table 2 and Figure 5, it can be seen that the hybrid sample with a weight percentage ratio of 3P:7K, at an impact energy of 1.5 J, the absorbed energy reached 1.47 J, the peak force about 4.54 kN, peak deformation around 7.66 mm while peak deformation energy had reached up to 1.86 J. (Ismail et al. 2019) carried a low-velocity impact on hybrid composite-based woven flax and carbon fiber and discovered that the absorbed energy reached 3.31 J for 5 kN. This is virtually identical energy absorption for hybridization of natural–natural hybrid composite. Therefore, this hybrid palm/kenaf is comparable with hybridization of natural-synthetic fiber

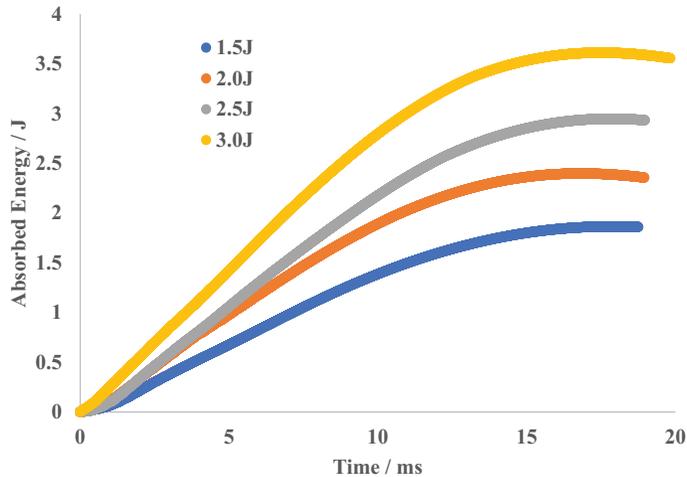
Figure 6. Energy vs time curve of 3P:7K hybrid bio-composites.

Figure 6 represents the energy curve against time of 3P:7K hybrid bio-composites. The absorbed energy is the energy absorbed by the specimen as a result of damage development and friction between the impactor and the specimen. The absorbed energy can be obtained from the curve of energy over time (Vaidya 2011), which indicates that the energy level becomes constant over a period. As seen in Figure 8, the absorbed energy increased as the incident impact energy increased. At the perforation impact stage (third stage), the impactor's energy was adequate to pierce the specimen. As a result, there was no decrease in the energy absorption curve, and the specimen dissipated the majority of the absorbed energy through damage propagation. The fiber length has a considerable effect on energy absorption since fiber acts as a load transfer medium. The longer fibers prevent crack propagation, and the shear force generated between them finally improves the impact strength. Additionally, Amuthakkannan et al. (2013) discovered that the length of the fiber had a major effect on the strength of the impact, and that when the energy impact exceeded the fiber strength, the fiber fractured.

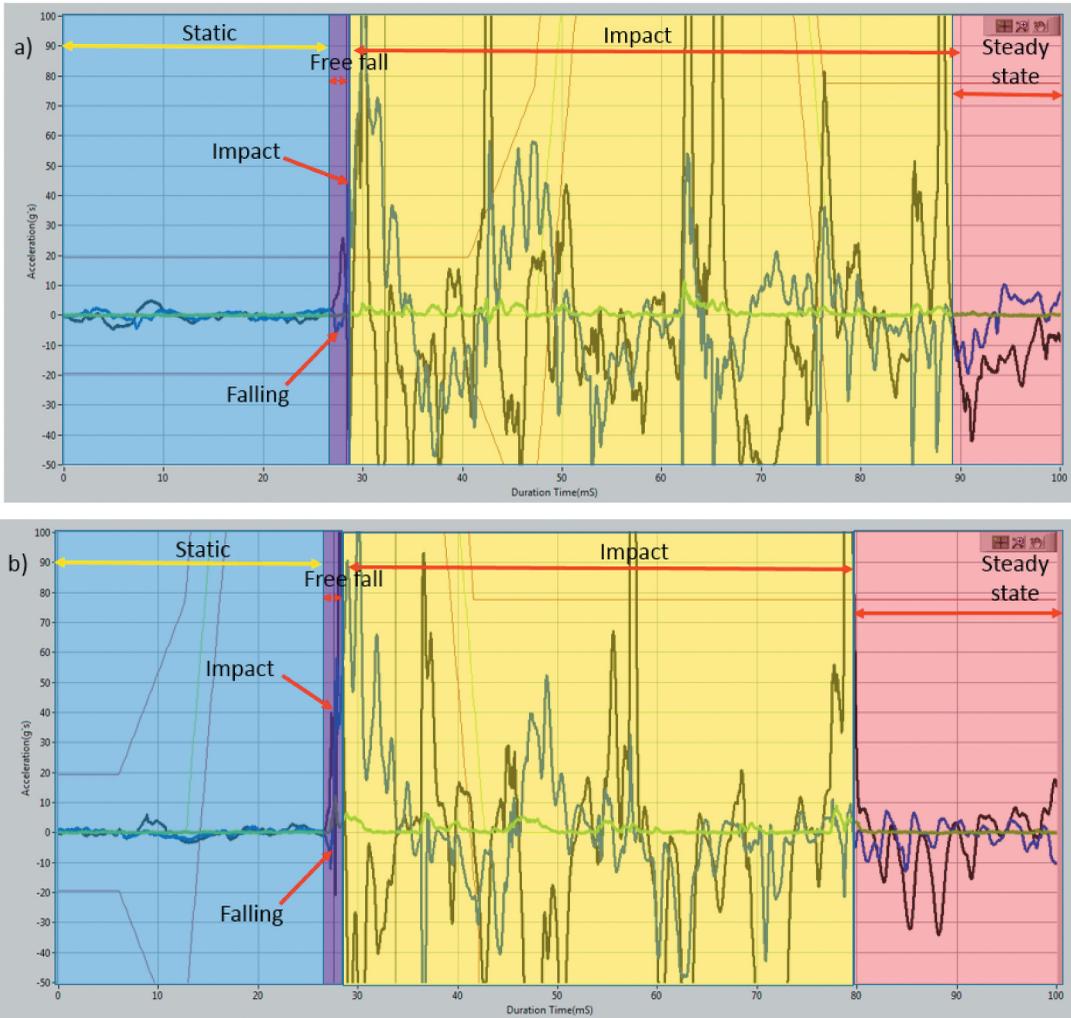
Figure 7. Gravitational acceleration versus time at a) horizontal position and b) vertical position.

The acceleration of free-falling objects is referred to as gravity acceleration. Figure 7 shows the curve of gravitational acceleration versus time, in the direction of X, Y, and Z axes, when the tray table was dropped from an altitude of 130 cm. Based on the graph, the gravitational acceleration versus time can be divided into four modes: static, free fall, impact, and steady states. The steady state is where the tray table was dropped from the dropping arm and fell down in 26 ms. The length of each mode for the

horizontal and vertical positions were almost identical; however, the impact mode for the horizontal position was found to be longer. When the tray table fell vertically, it returned to the steady state more quickly than when it fell horizontally.

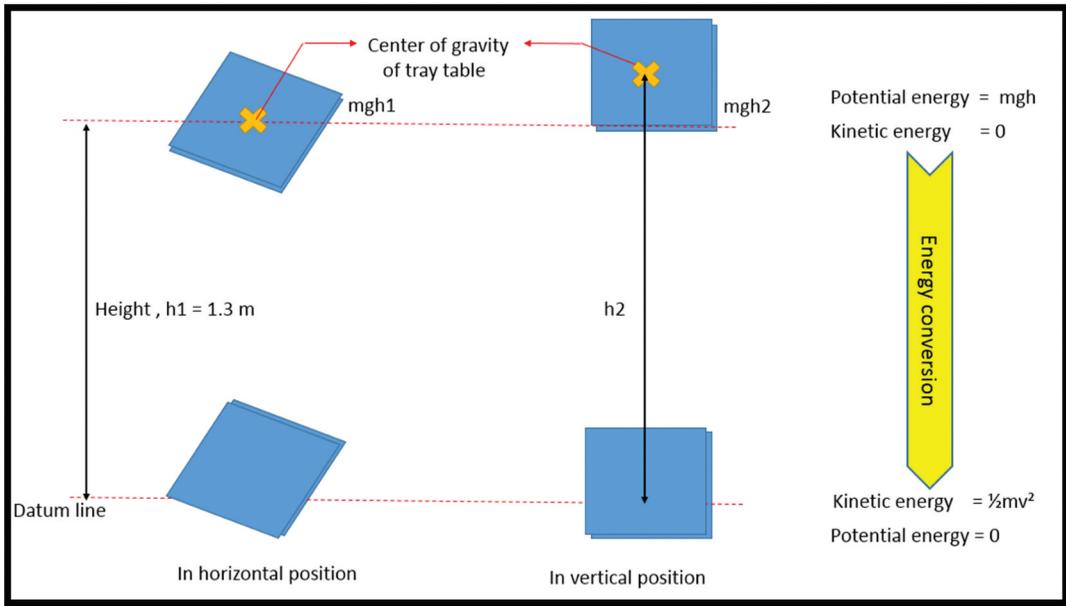
Figure 8. Energy conversion.

As shown in Figure 8, the free-fall drop test principle is related to energy conversion, in which gravitational potential energy at rest is converted to kinetic energy. Even when the vertical and horizontal positions of the dropping arm maintained the same altitude, the exact height of each position varied significantly. The exact height was calculated from the datum to the center of gravity of the tray table. Therefore, the potential energy of the tray table in a vertical position was slightly higher compared to a horizontal position. In the vertical position, the impact duration is shorter compared to the horizontal position, thus sudden impact may lead to severe damage. During the maintenance of the tray table when it falls in the horizontal position, the damage will be lesser compared to vertical position.

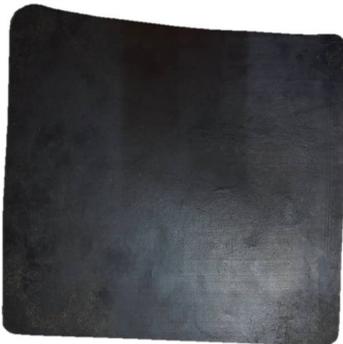
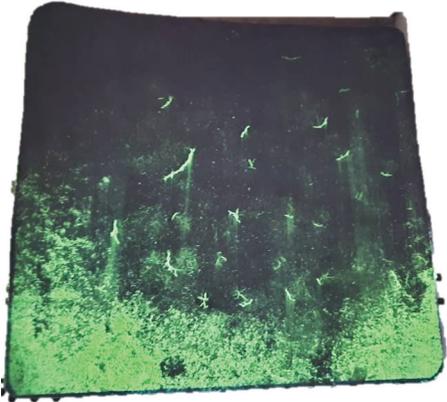
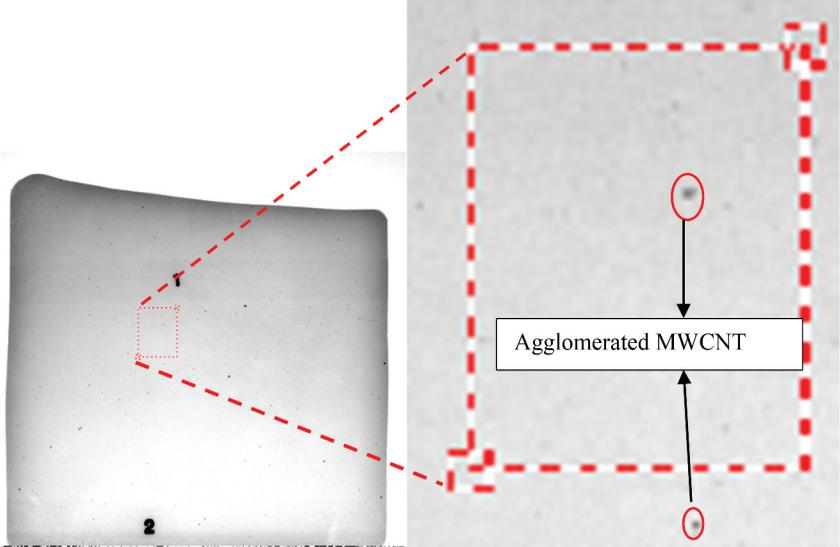
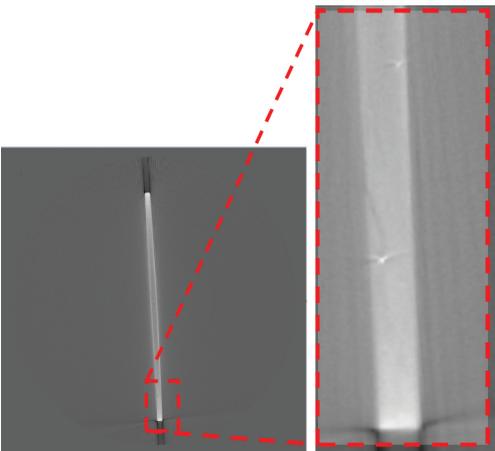
Table 5. Results of NDT inspection on LVI specimens.

Types	Prototype tray table
Visual inspection

Dye penetration

DDA

Types	Prototype tray table
CT-scan

[Table 5](#) tabulates the dye penetration and DDA results. As seen in [Table 5](#), matrix cracking was observed on the composite samples, with impact energy levels ranging from 1.5 J to 2.0 J, 2.5 J, and 3.0 J. It was found that the matrix cracking propagated from the top to the bottom of the rectangular plates and from the middle (indentation) to the outer edges. The matrix crack propagation was halted until it reached the sides of the materials, preserving the rectangular shape of the sample without perforation. The use of micro-sized fibers with a random orientation limited the damage studied. Hence, no pattern can be proposed about the association of the impact energy levels with the magnitude of the damage incurred (Shah, Sultan, and Safri 2020; Živković et al. 2017).

For the tray table after the free-fall drop test, some small cracks were observed using dye penetration method. However, the small cracks were not visible using the DDA method. According to the enlarged image of the DDA, dark spots were observed. This indicates the agglomeration of MWCNT. According to Aguilar et al., the agglomerated condition is described by an increase in the density of CNT-to-CNT junctions after the percolating network has developed (Aguilar, Bautista-Quijano, and Avilés 2010). Based on the density difference, the darker area implies more exposure with higher radiation level, while the lighter region indicates lesser exposure. According to a previous research, the FE-SEM photographs of MWCNT agglomeration in phenolic composites shown in Figure 10 demonstrate the MWCNT dispersion and that distribution is uneven and challenging to control (Ma et al. 2010).

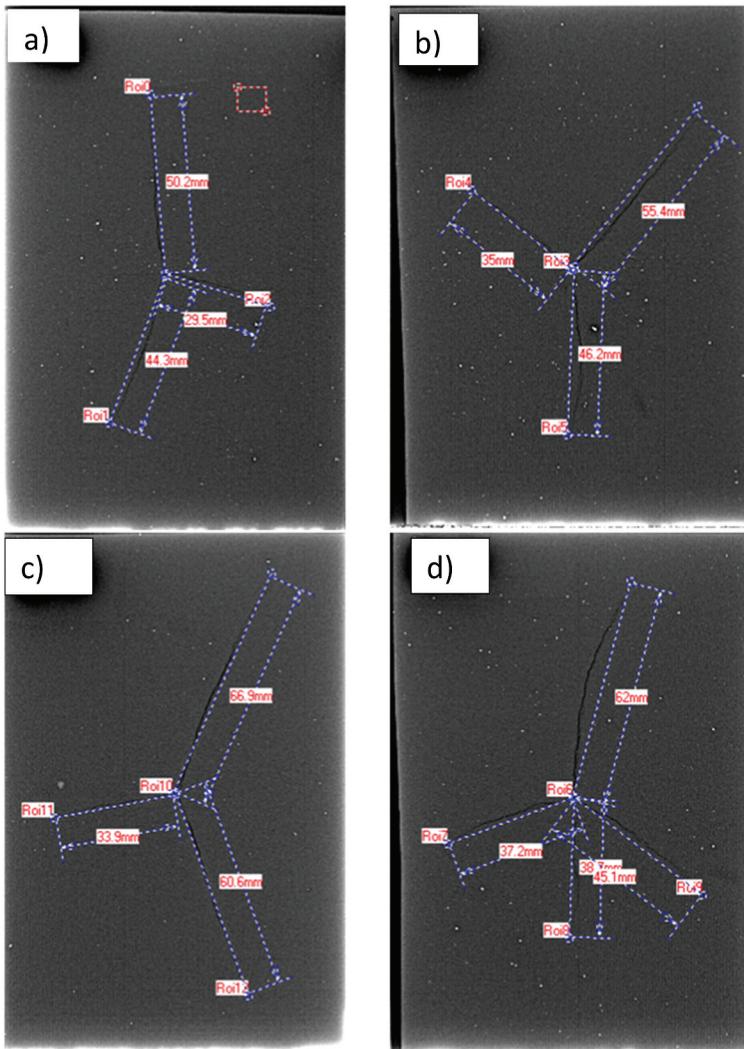
Figure 9. Sizing of the cracks from DDA images of (a) 1.5 J, (b) 2.0 J, (c) 2.5 J, and (d) 3.0 J.

The length of the crack extended as the impact energy increased from 1.50 J to 3.0 J, as seen in Figure 9. This is supported by the fact that the damage area increases as the incident impact energy rises. A similar finding was reported by (Shah, Sultan, and Safri 2020), who carried out dye penetration on LVI samples made from bamboo-reinforced epoxy composites when the impact energy varied from 2.50 J, 3.75 J, and 4.40 J. The crack pattern in both tests was similar, and the size of defects were measured. A significant difference of approximately 3–15% in the defect sizing between both test results was found. If the dwell time was set to 15 min after developer application, this composite material would be erect to liquid and the crack would thicken, as shown in the 1.5 J and 2.0 J images (top). Therefore, the measurement of the crack length in dye penetration may have a small significant difference compared to the sizing made with the DDA results.

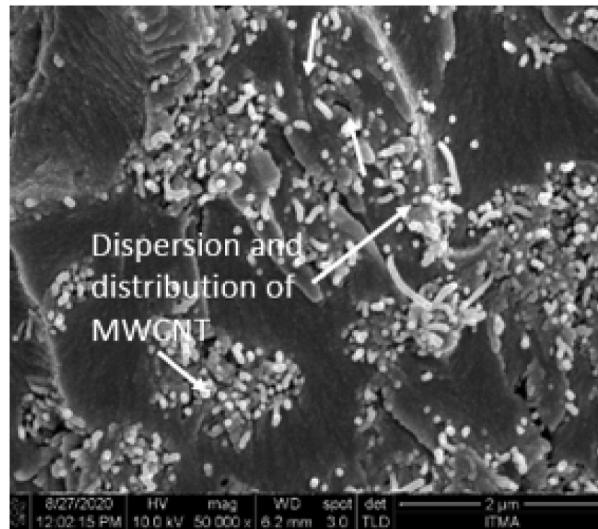
Figure 10. FE-SEM images of 3P:7K specimens at magnification of x50000 (Loganathan et al. 2021).

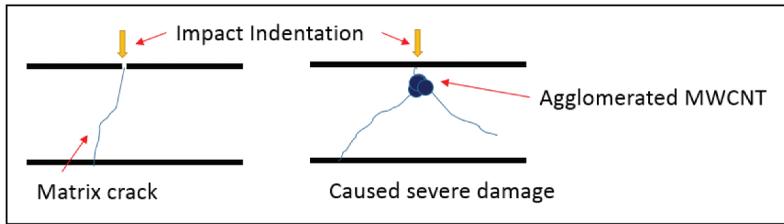
Figure 11. Crack propagation during impact energy on composite sample.
